**U.S. ENVIRONMENTAL PROTECTION AGENCY, REGION II**

**MEMORANDUM**

**DATE:** July 19, 2017

**SUBJECT:** Northrop-Grumman/Navy Bethpage  
Nassau County Storm Water Basin 495  
Arthur Street, Bethpage

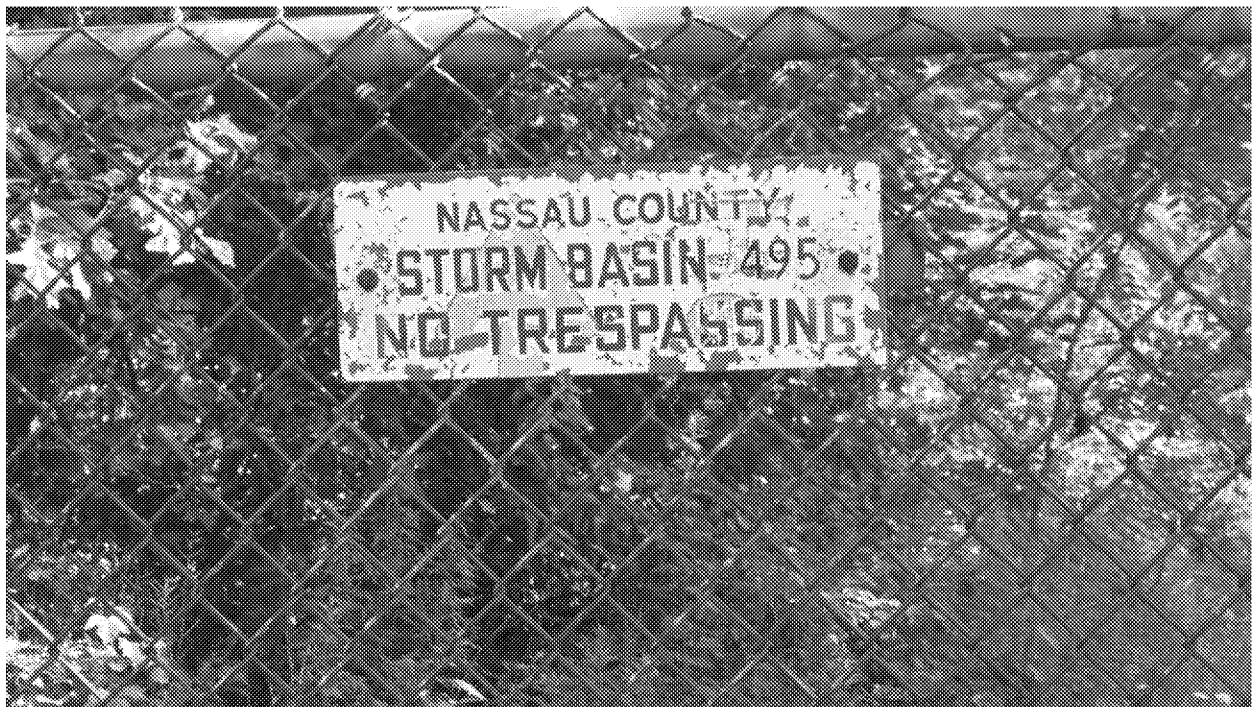
Identification sign posted by main access gate, NC Storm Basin #495, Bethpage

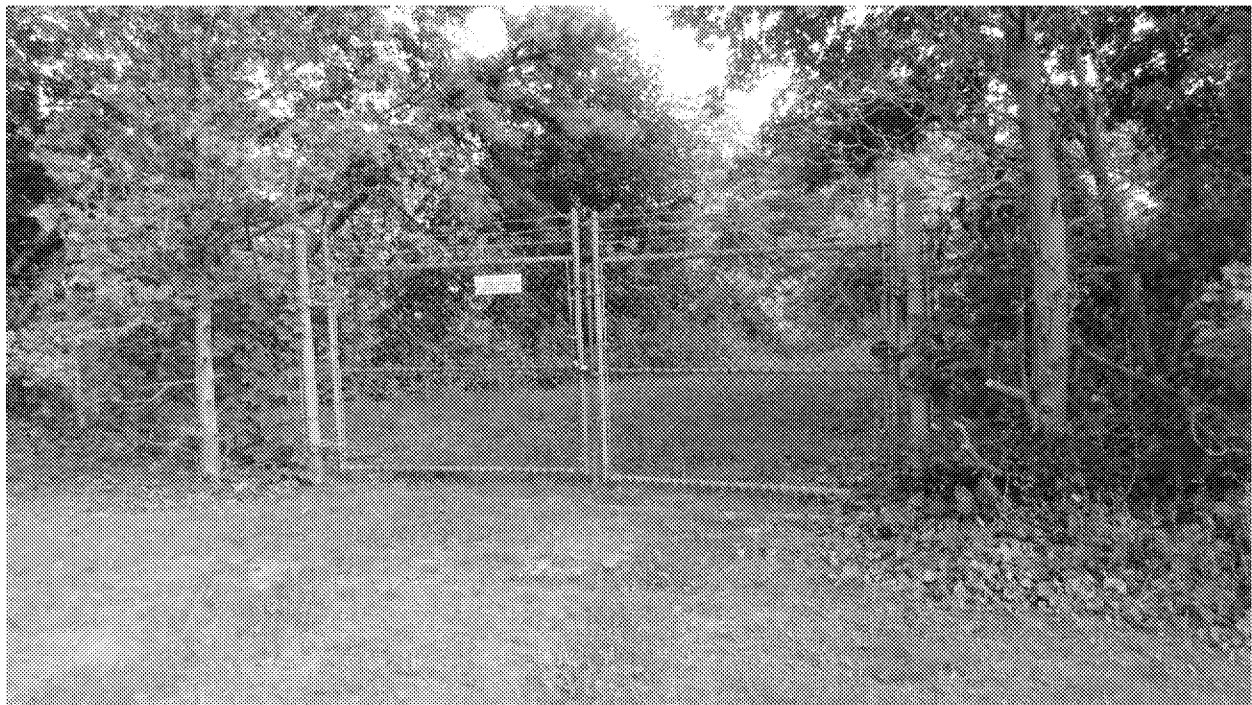
View of main vehicle access gate, Arthur Street NCDPW Basin #495, Bethpage

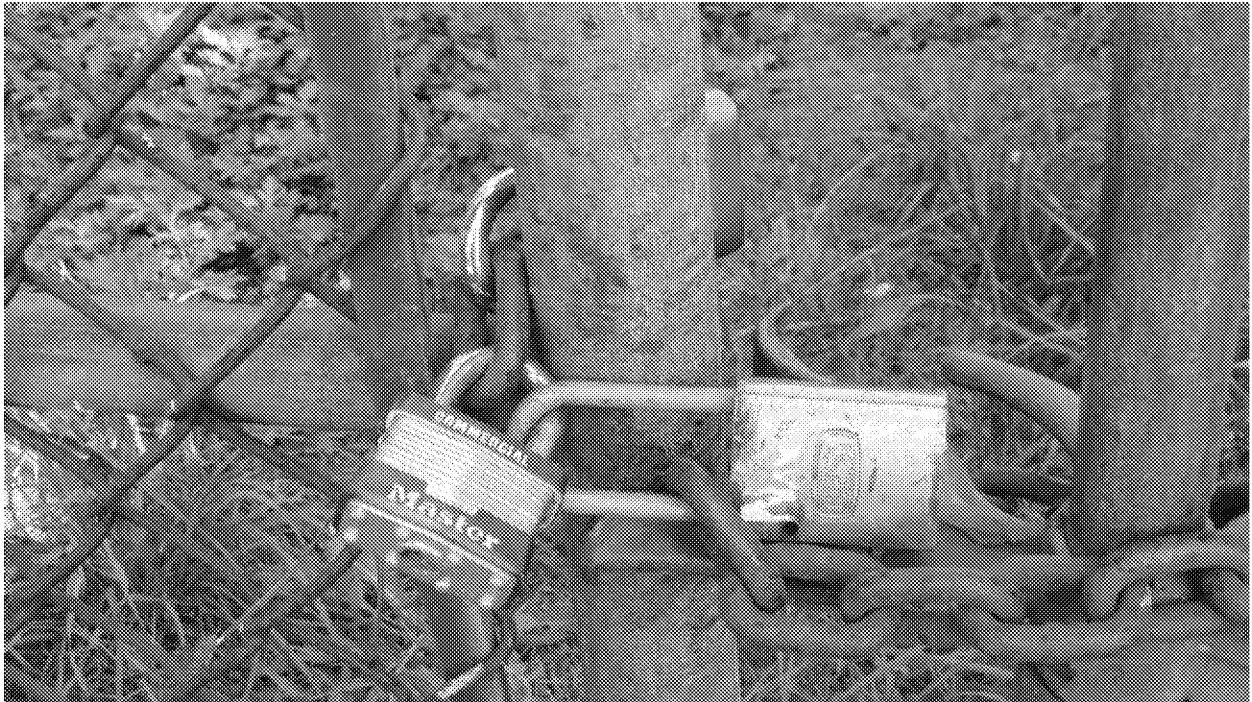
Detail of inter-locked keys on chain at access gate, Basin 495, Bethpage

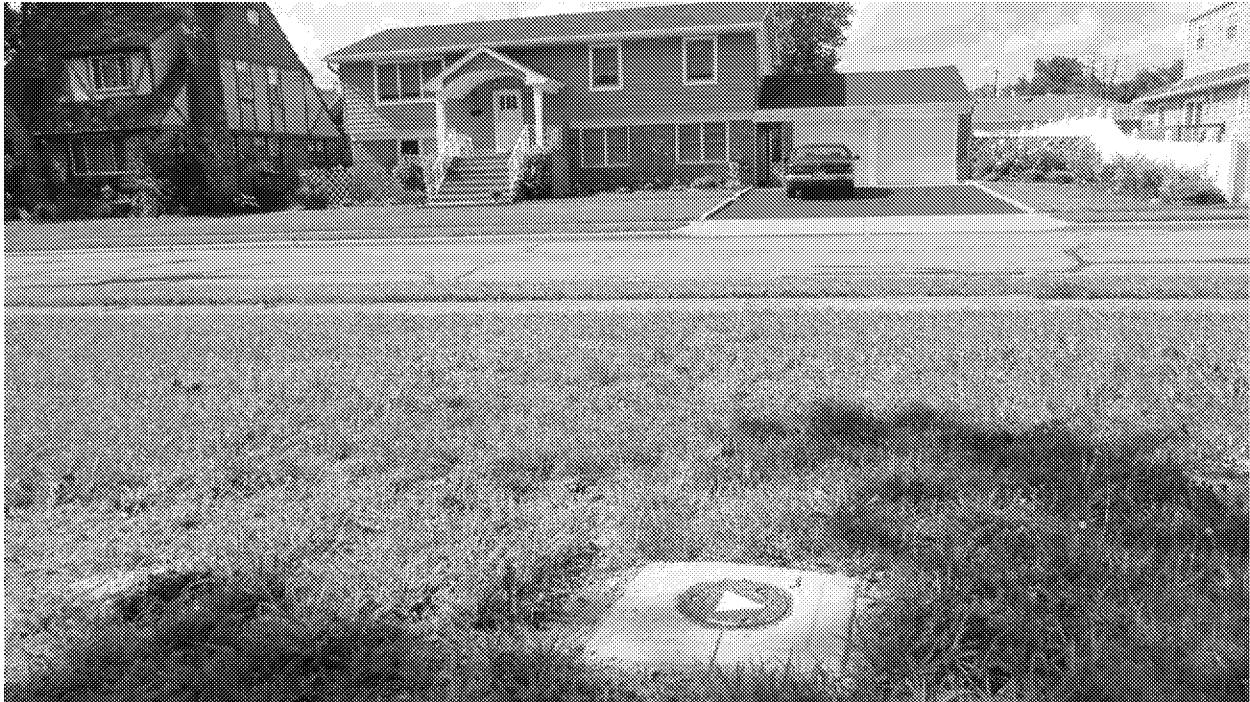
Two completed observation wells were observed. These wells appear to be recent and have concrete pads protecting secure flush mounted wells. They appear to be completed in accordance with the current Navy program. One is opposite 75 Arthur Avenue, and the other near the Broadway-Arthur Ave intersection. I'll request the well numbers, logs, and latest sampling results.

View of Monitoring Well opposite 75 Arthur Avenue, Bethpage

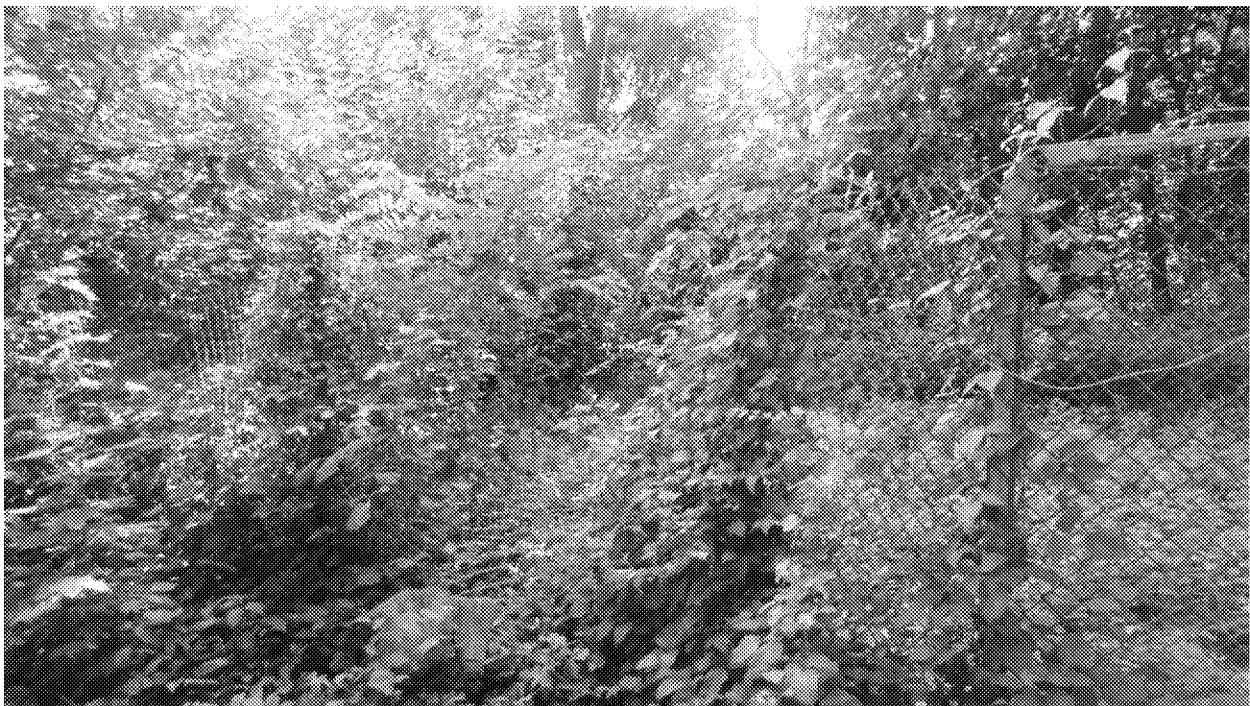
The west and east sides bordering the County fence are overgrown with vegetation. The barbed wire and portions of the fencing have significant gaps as are shown on the photographs at the end of this memo. The north side of the basin fence is in good condition with only 1 post bent and no holes observed. The south side appears somewhat a concern as the fence directly abuts residential backyards, and some lots have an additional fence buffering a roughly 8-foot distance with the County fence which limits access for maintenance activities. One home has direct access onto the overall County parcel, with direct access to the basin property as a result of removal of roughly 16 feet of fencing and almost all barbed wire. Vegetative and other debris has accumulated in this vicinity outside the actual basin fencing. Older holes in the chain link fence were observed, but some homeowners had installed their own privacy fencing so no access either way was possible.

Vandalized fence, northeast side of Basin 495 near Broadway, Bethpage Note tree stump used as stepping platform

Some maintenance is suggested and it would be appropriate to review the design capacity to confirm the maximum amount of water the basin can mitigate without impacting the nearby residents. I observed that 2 small saplings were recently planted (and staked) along the Arthur Ave setback. Presumably these were by a local homeowner as an effort to add more tree cover and variety to the area. That is a sign that some residents have an interest in their local area environment. I have no objection to that, and hope they thrive.

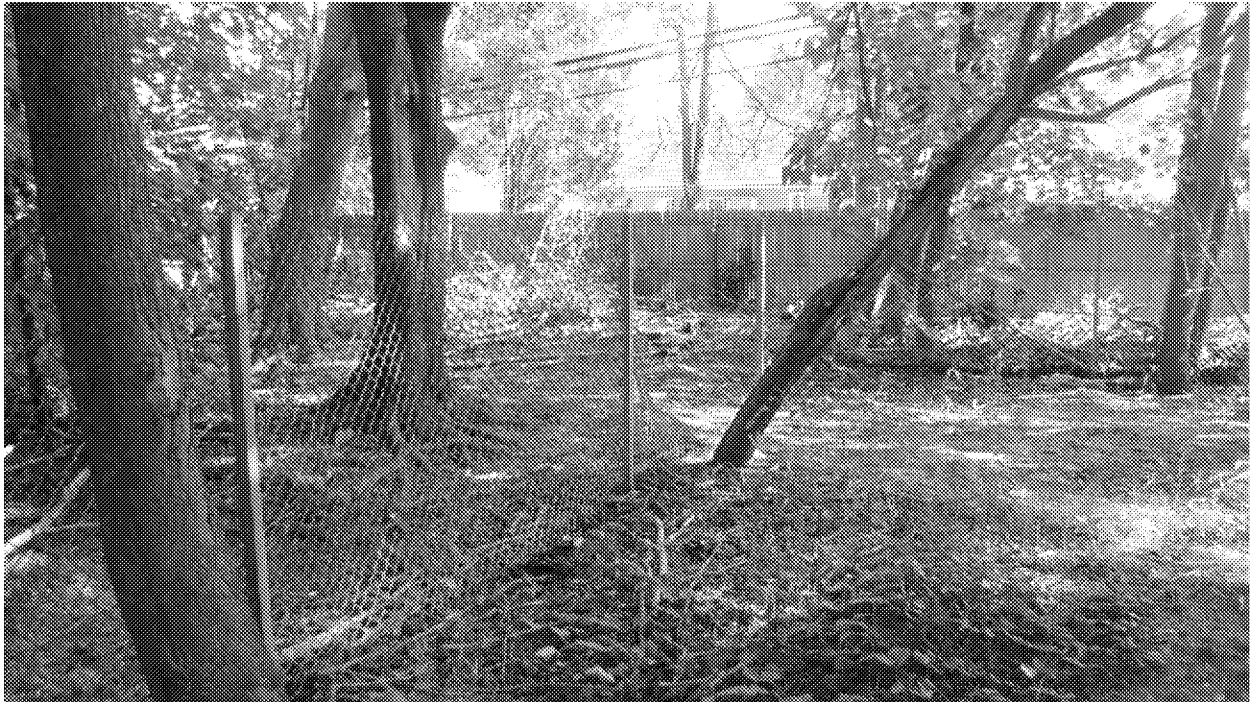
View of missing fence chain and barbed wire, Southeast side Basin 495 near N Millpage Dr properties, Bethpage, NY. Note accumulated debris.

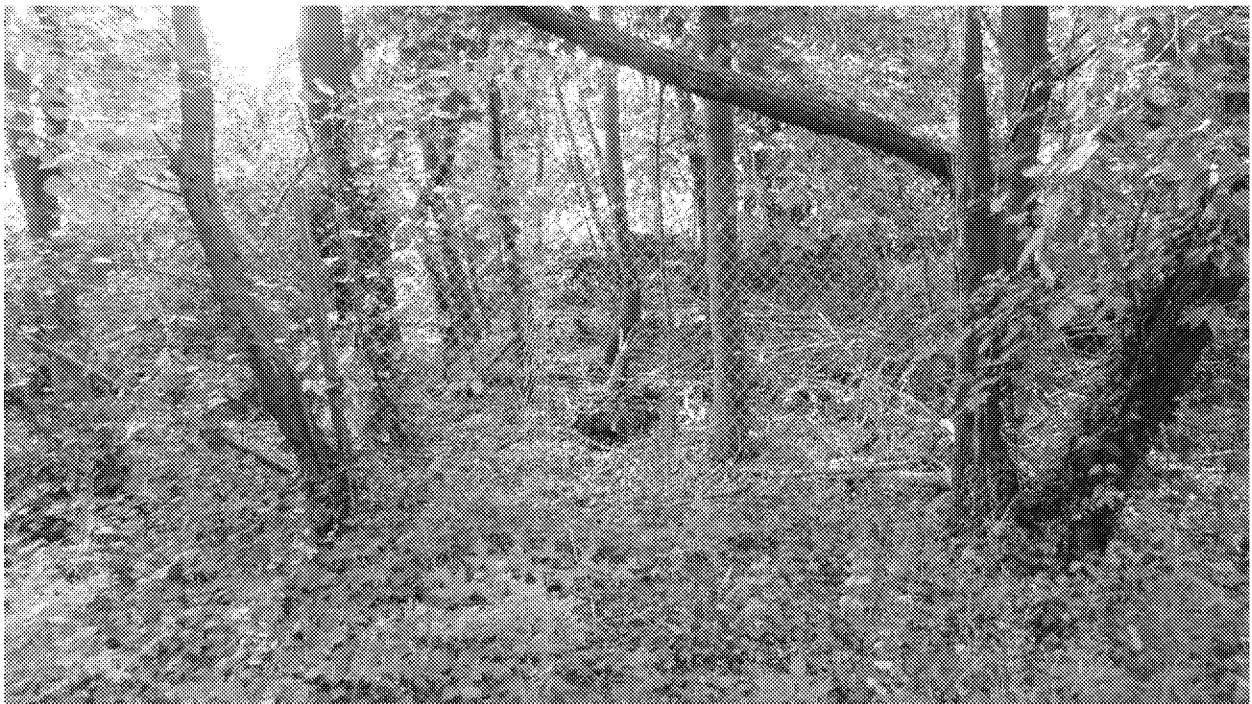
View of apparently recent cut of chain link fence, east side near southern border and Stewart Ave, Basin 495

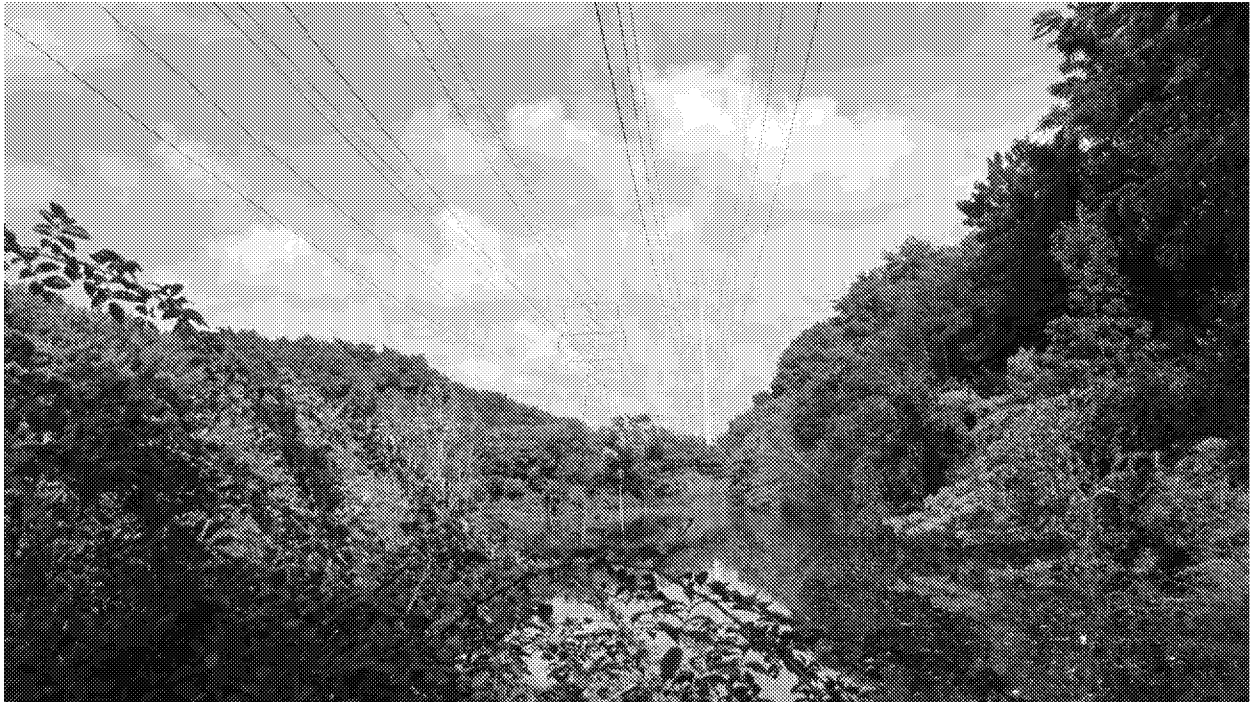
View looking east from edge of ponded area, note transmission tower & lines, Basin 495, Bethpage

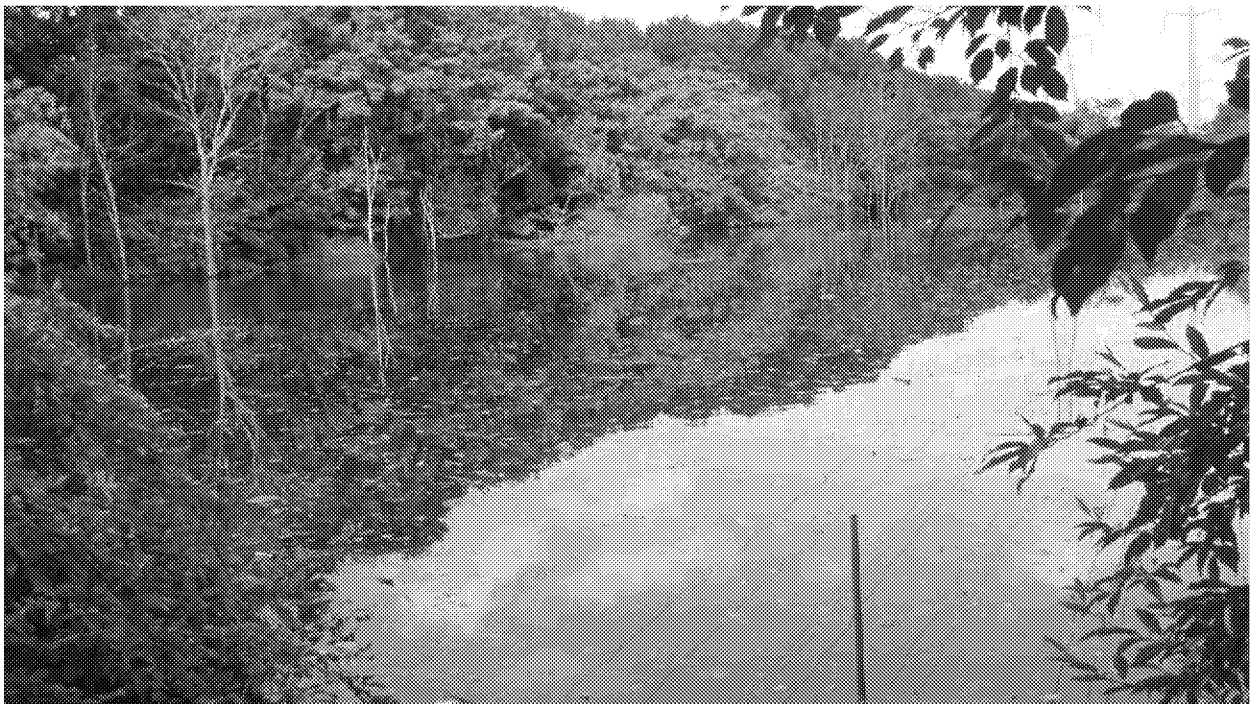
On the inside of the maintenance path, the slope of the basin is roughly 45 degrees extending downward to the bottom. The slopes are almost completely covered with vegetation including numerous Norway Maples, poison ivy in areas, multiflora rose, and some pines. The bottom is fully ponded, but little access is possible due to the overgrowth. A few plastic containers were observed, but no significant accumulations. This is a closed basin, and plastics that flow in or enter do not have an exit route. The water appeared clear and there was a bit of duckweed along the edges. I was not able to estimate the depth, but could not observe the location of the inlet pipe or pipes leading to the basin. The vegetation along the basin slope did not exhibit evidence of inundation or erosion (slope failure) if the area water level increased significantly due to a storm event. Two mallard ducks were observed swimming in the water during my recon, and I noted the presence of a few dragon flies. I did not use insect repellent during my walk, but did not observe any mosquito bites.

View looking northeast of ponded are from edge on West side. Note limited debris observed. Basin 495, Bethpage

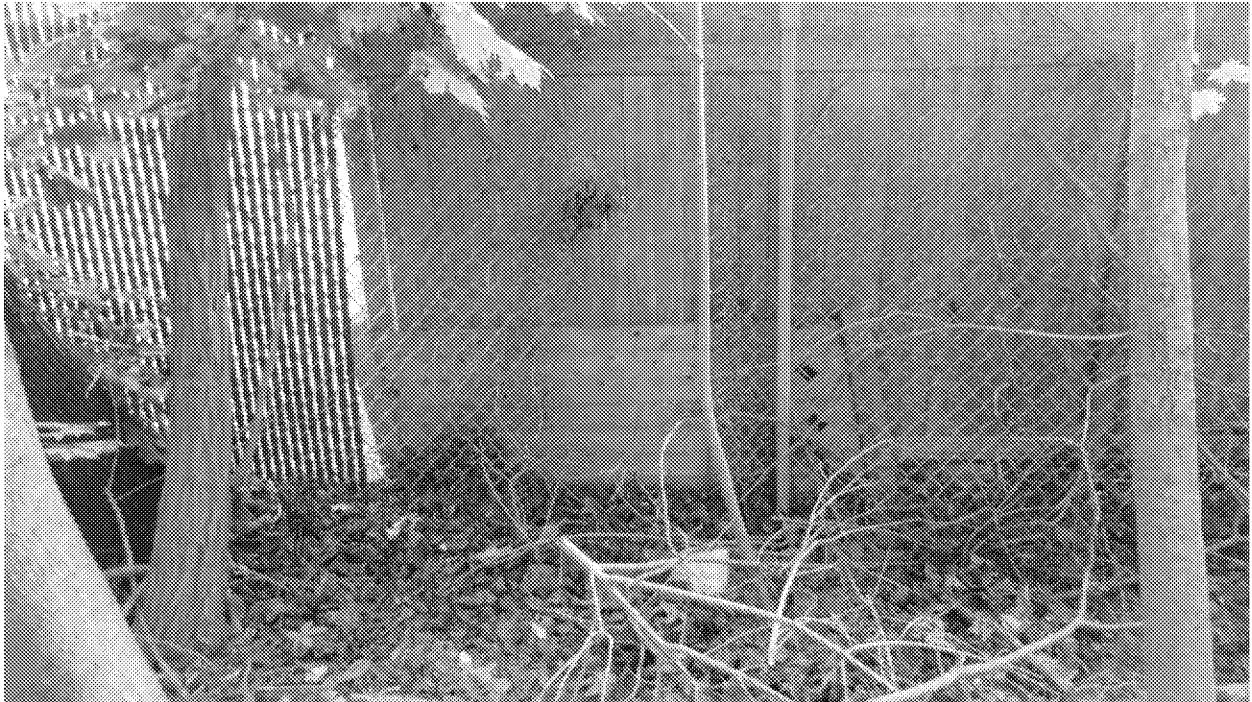
View of south side of Basin 495 adjacent to property owner along N Millpage Dr., Bethpage  
Note new private fencing and older gap in County fence.

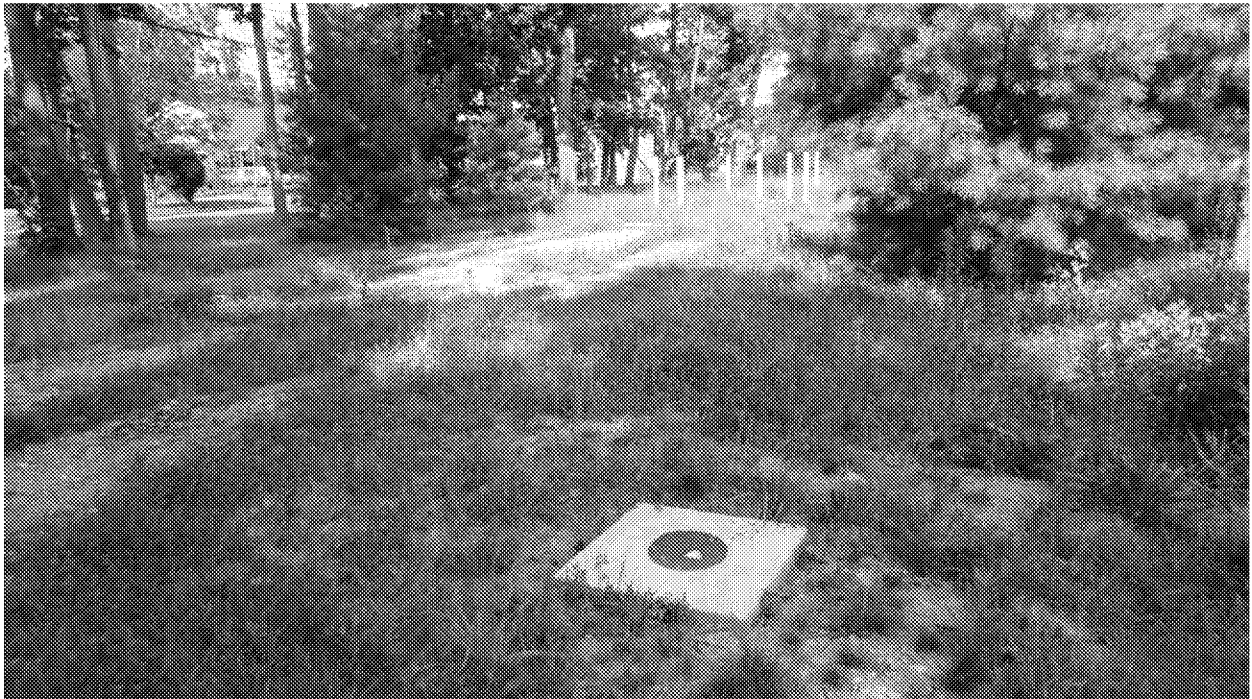
View of Monitoring well, near Arthur Ave and Broadway, Bethpage. Bollards protecting vault to transmission electrical facility in background.

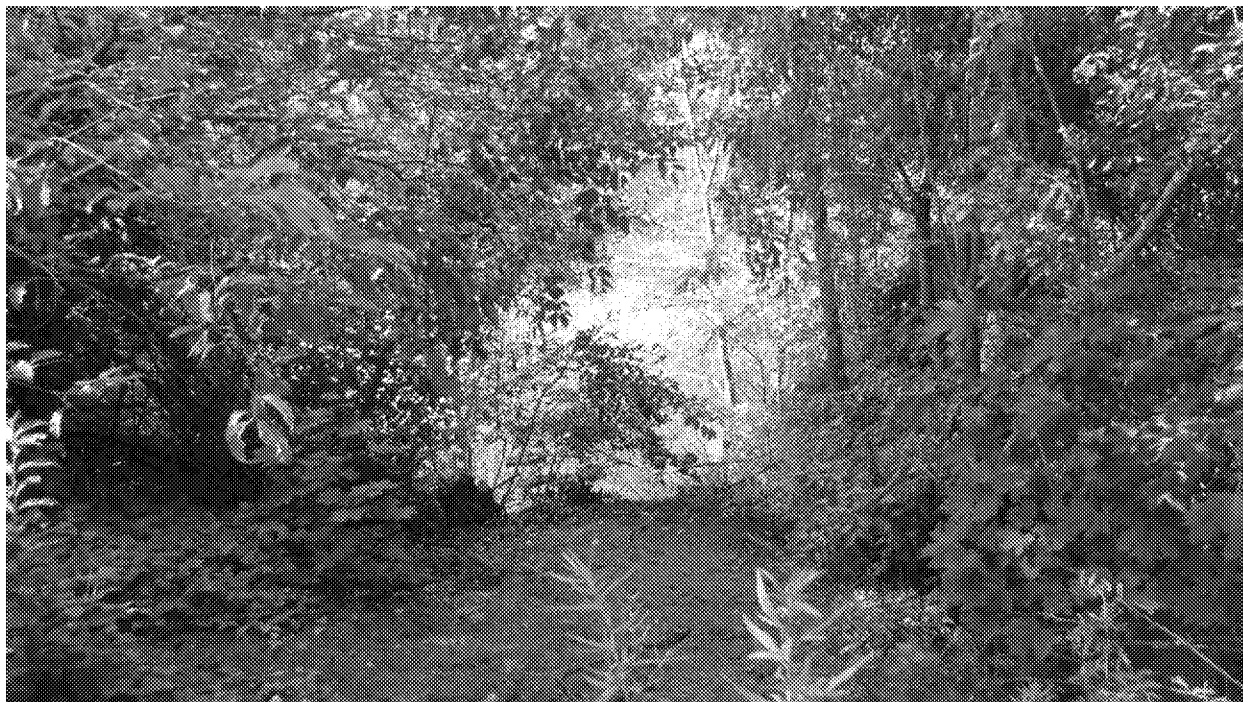
View of slope and bottom of basin from South maintenance path Basin 495, Bethpage

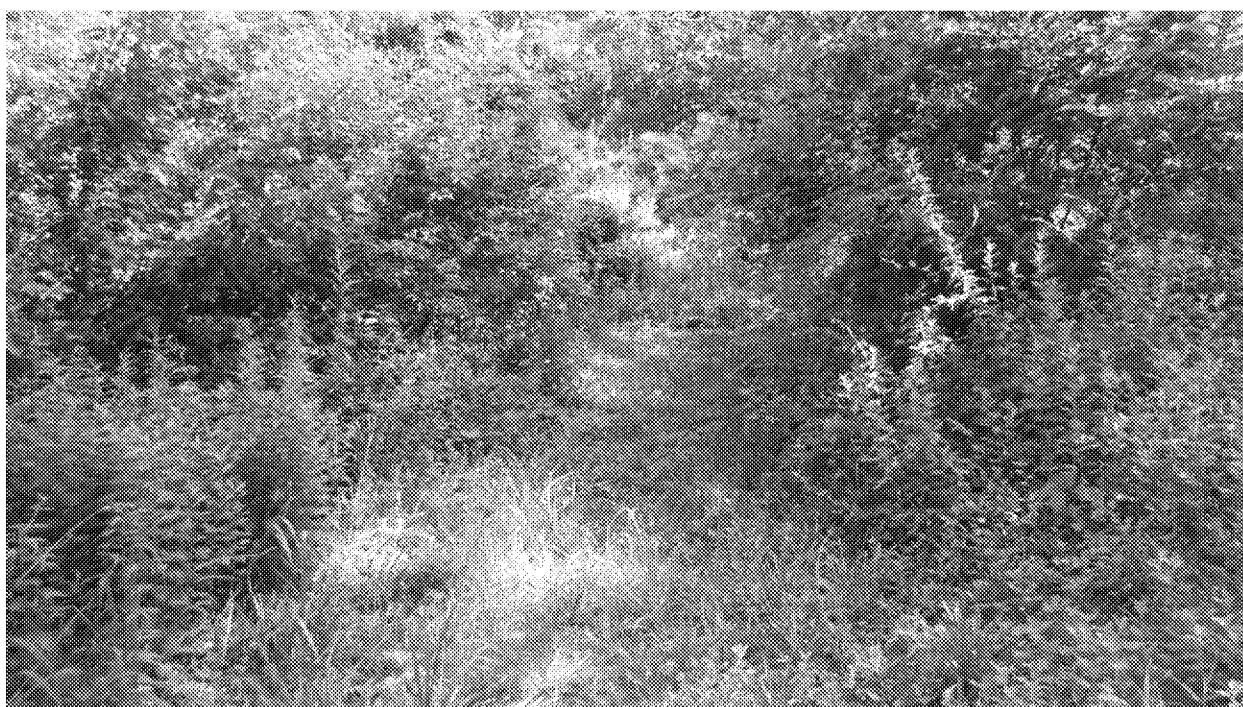
Within the fenced area, the basin is surrounded by a roughly 6-foot level area used as a maintenance pathway, and an unpaved vehicle ramp leading down to the bottom from near the access gate. The ramp-way and a good percentage of the maintenance pathway are overgrown, still functional and serve the purpose of deterring trespassers. No accumulation of beer cans or other evidence of youth congregations was observed within the basin.

View of vehicle access ramp from basin bottom towards access gate, Basin 495, Bethpage

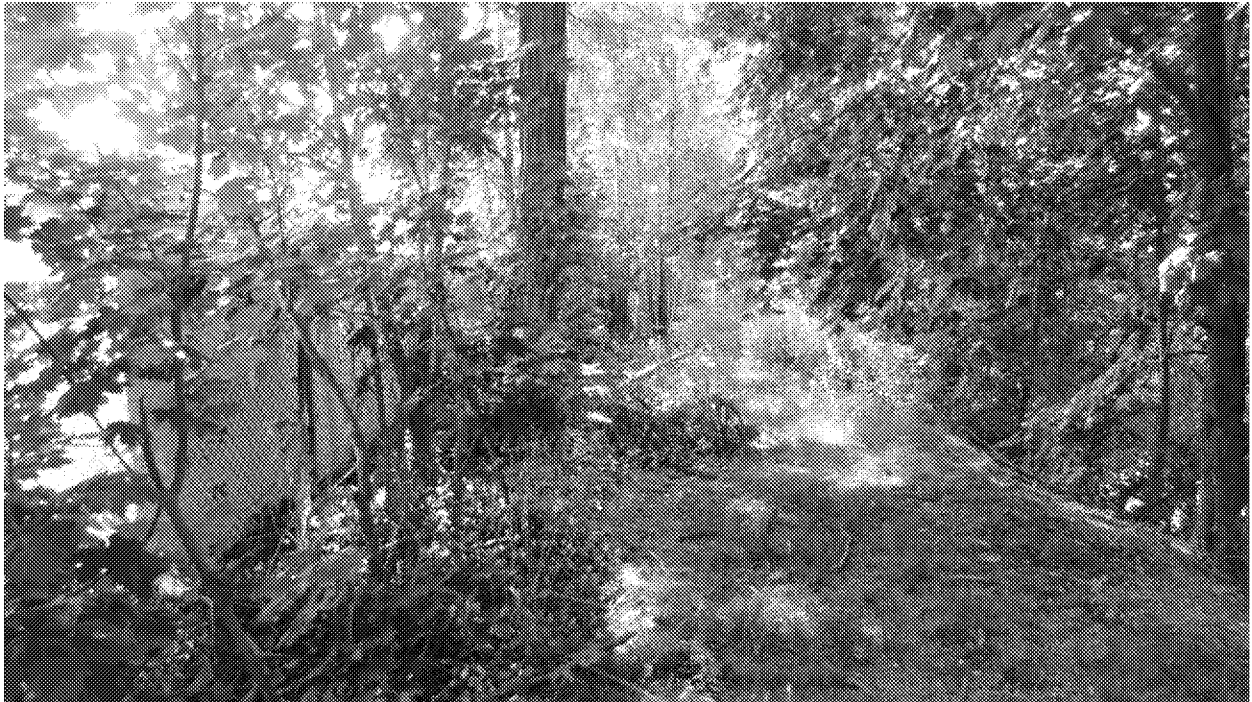
View facing West along access pathway, south side Basin 495, Bethpage

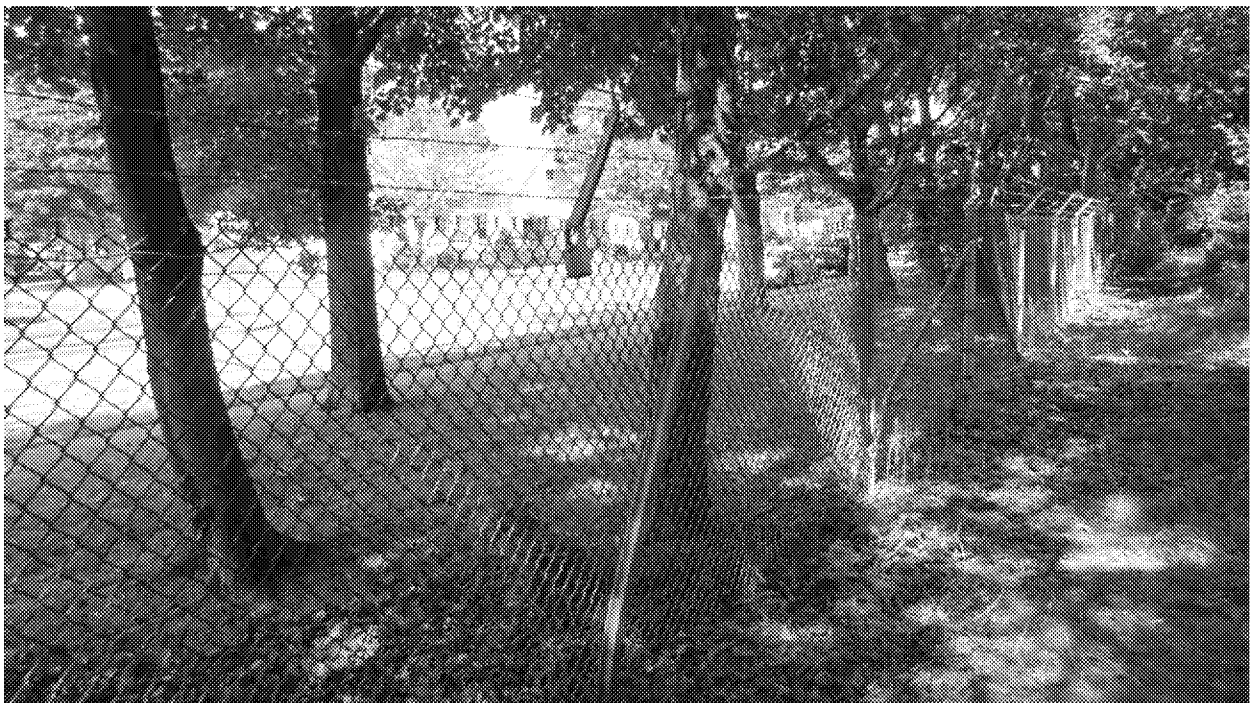
View facing northeast towards Arthur Avenue, post bent along north border, Basin 495, Bethpage.

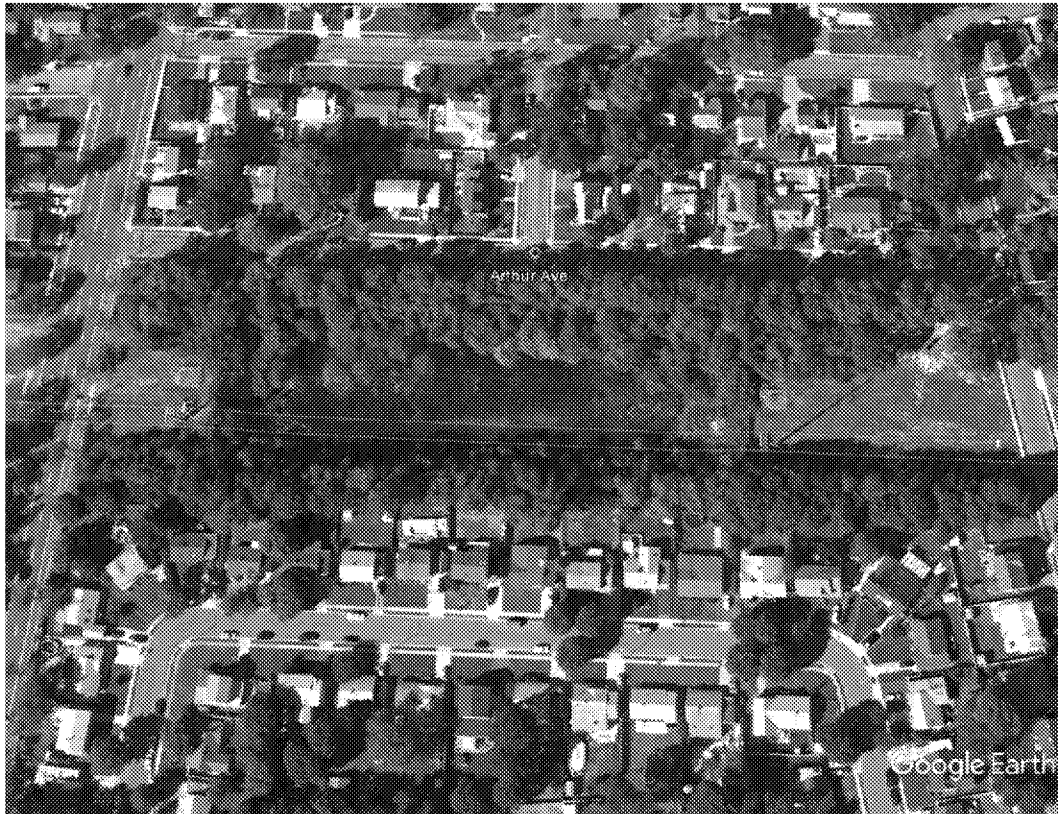
A brief review was also made of available Google Earth images for this site. The basin appears to have been a "dry" basin from the earliest images (1994) through 2009. Subsequent to that it appears to be ponded. It appears that vegetative overgrowth in the bottom was removed. A 2007 and 2010 image are included below.

Basin 495 Google Earth photo Sept 2010

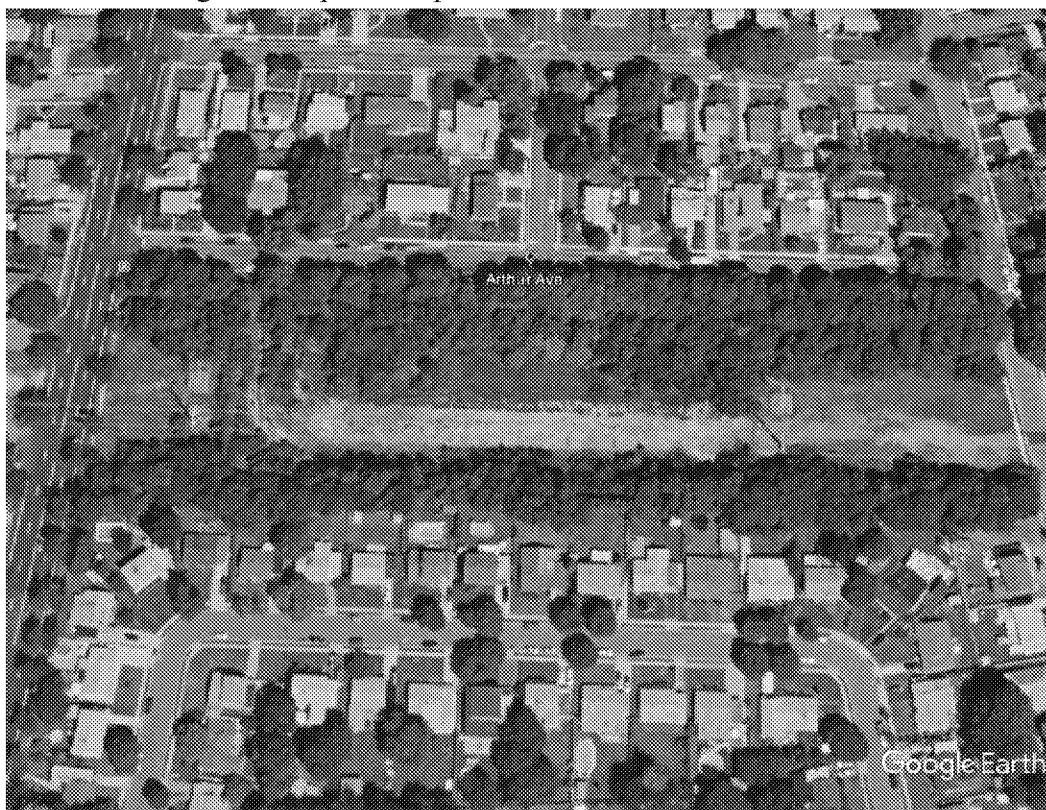
Basin 495, Bethpage Google Earth photo July 2007
